STRUCTURAL SURVEY

A PROPERTY IN
SAN JOSE
NIJAR, ALMERIA

7TH NOVEMBER 2007

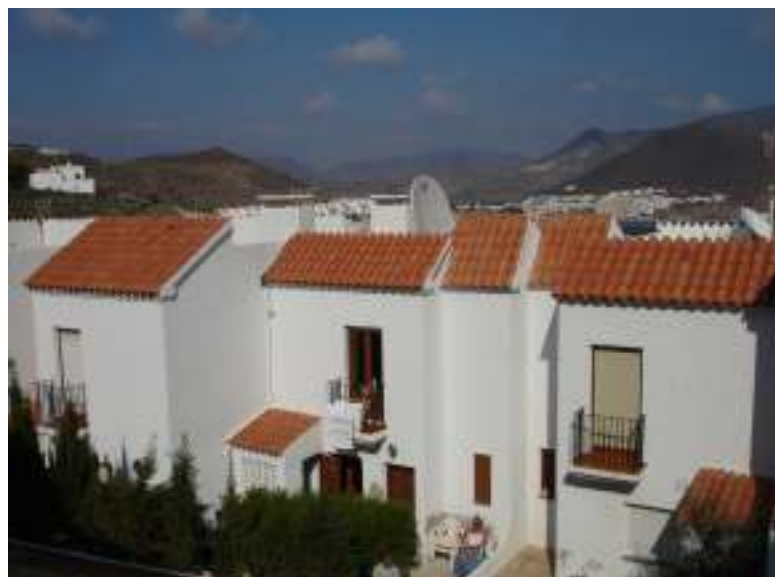
There are several missing tiles to the mansard roofs and other sloping roof areas and these need immediate replacement. These should be replaced using exterior tile adhesive and the firmness of the fixing of the other tiles should be checked at the same time.

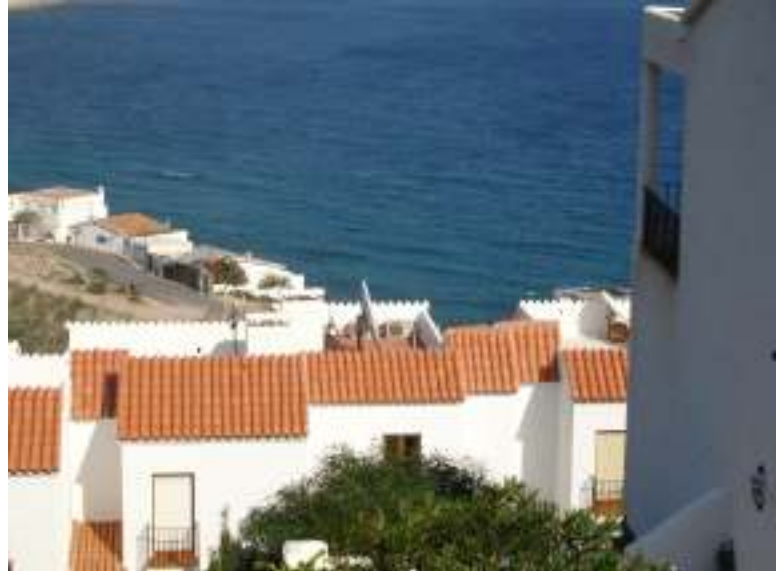
Several tiles are chipped to the front edges but are serviceable.

Whilst this work is undertaken it would be sensible to further check the condition of the flat roof, tiling and grouting.

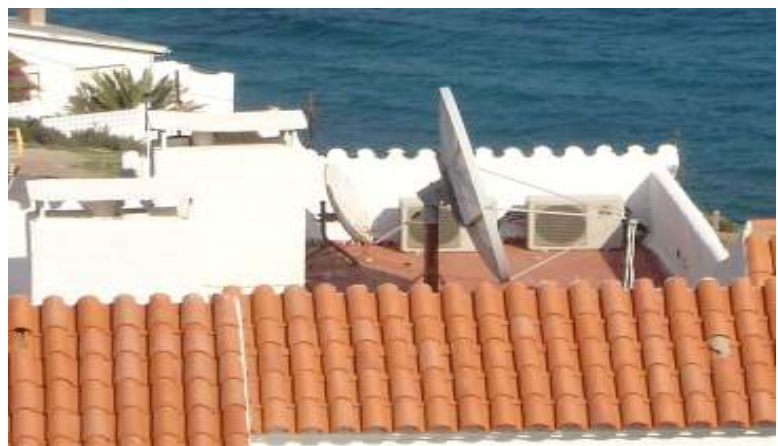
The chimney stack is in a reasonable condition although the capping to this is cracked and bowed and may require replacement.

There is a redundant aerial pole that could be removed.

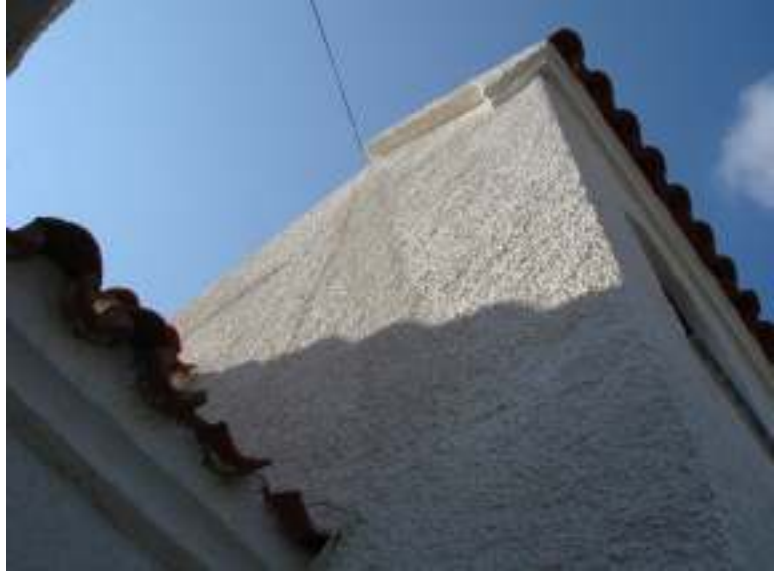
There are slight horizontal hairline cracks to the right hand side of the front elevation but these are not of a serious nature

and are again due to slight initial differential shrinkage between the different constructions as advised above. These should be filled prior to painting.

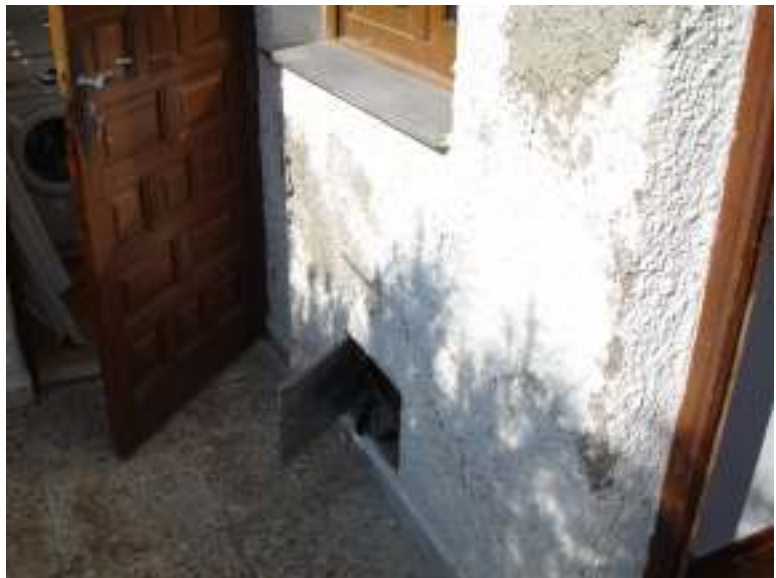
The rear elevation and outbuilding are in a reasonable condition. The render and walls at low level have been affected by damp and the render has been repaired but is still spalling. The cause of this dampness is further reported upon under the heading of Dampness later in the report.

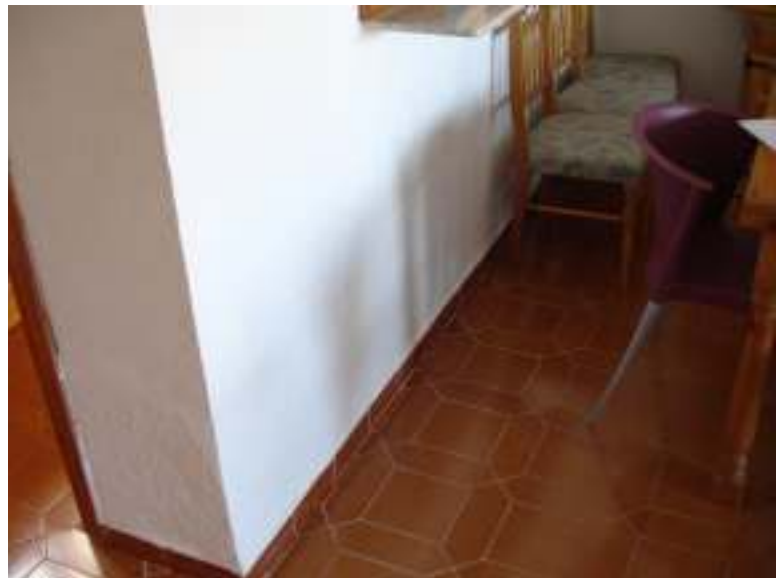
The walls to the kitchen are have been affected by damp at low level.

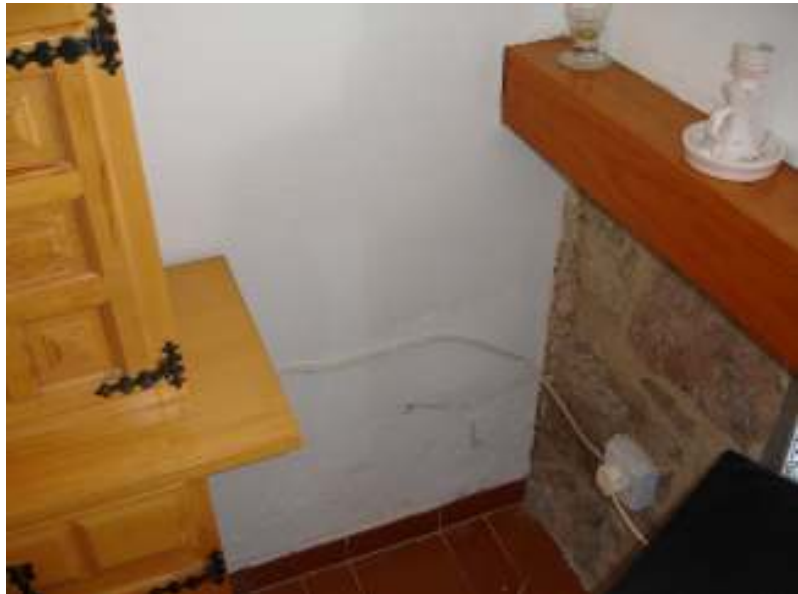
As previously reported there has been a problem of dampness to the rear main walls to the property and outhouse, to the rear internal walls around the rear door, to the walls to the kitchen and to the right hand wall to the rear of the fireplace.

These areas have been repaired to the render and plaster and repainted.

The new paint and, to a certain extent, the new render and plaster are spalling and still affected by damp.

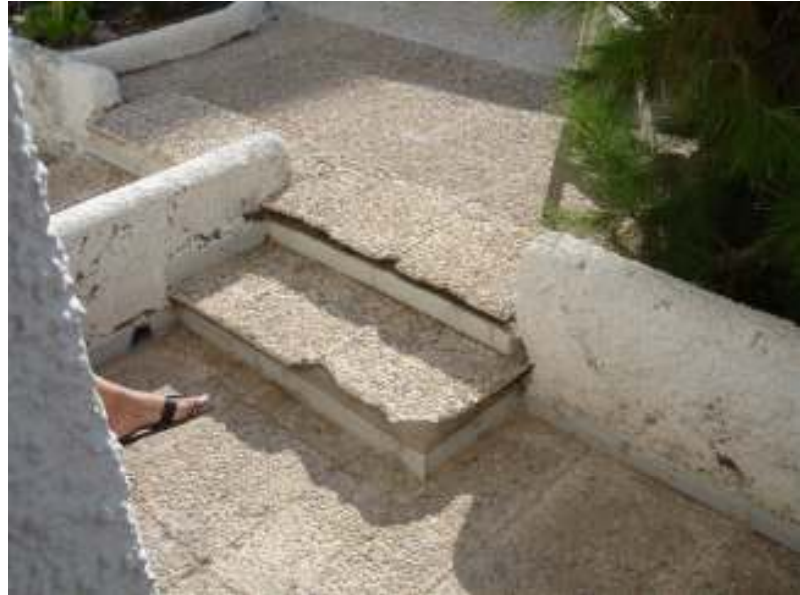
Immediately to the rear of the property there is a lower paved

area which is at the same level as the marble threshold to the rear door.

The pavings to the pool surround and pathways above this area all fall towards this area. There are 2 paved steps between the two but these are damaged.

During heavy rainfall this lower paved area must flood as there is no provision for surface water drainage. Such flooding will affect the rear walls and also get under the rear door as there is no protection to stop it. This will allow surface water into the property and affect the walls internally in particular to the kitchen and rear part of the lounge.

To rectify the problem the steps should be repaired and a drainage soakaway should be installed.

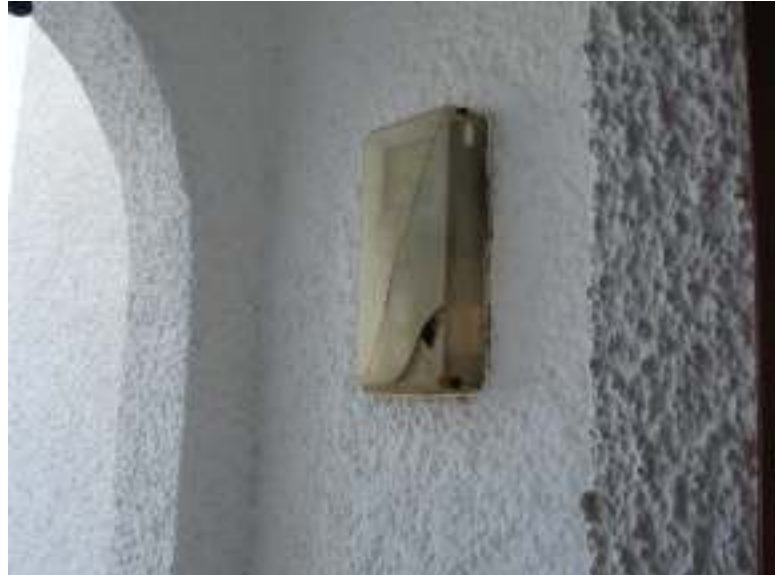
The meter housing cover is cracked and broken and requires replacement. A surge protector may also be required but this is not mandatory on an existing installation.

Some of the electrical fittings are loose and marked and these would benefit from upgrading. An English style socket outlet has been provided to the fire – this is acceptable.

The external light fitting to the front of the property is broken and requires replacement.

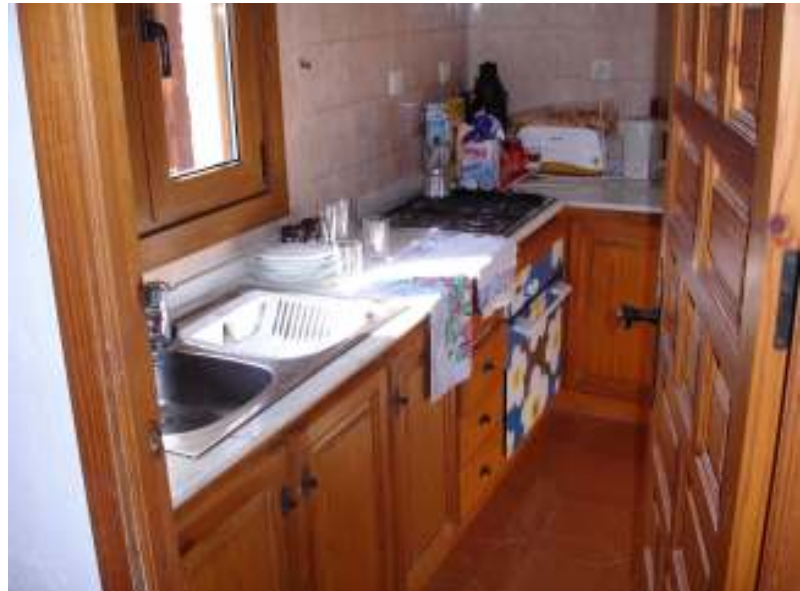
The kitchen appliances are generally worn, broken and affected by the previously reported dampness. The worktops are also broken and this area requires complete upgrading.

The sink mixer tap is loose at present and requires immediate re-fixing.

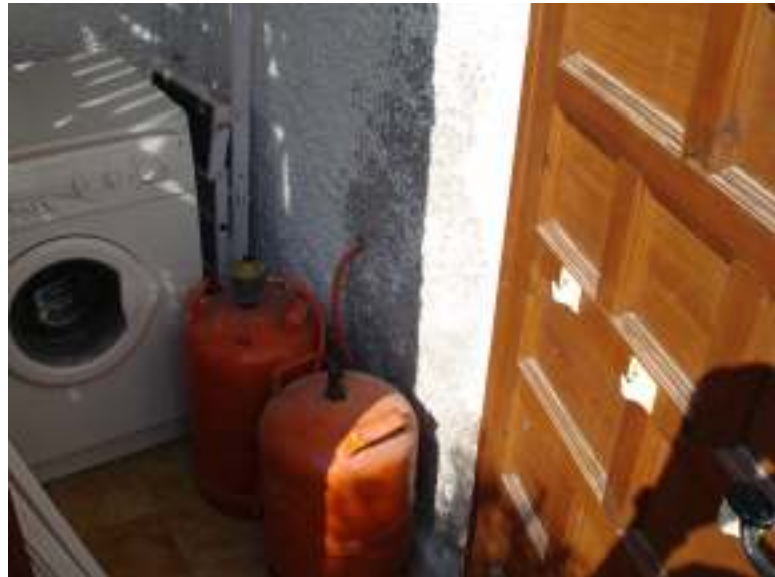
The single storey outhouse is in a reasonable condition although affected by the previously reported dampness.

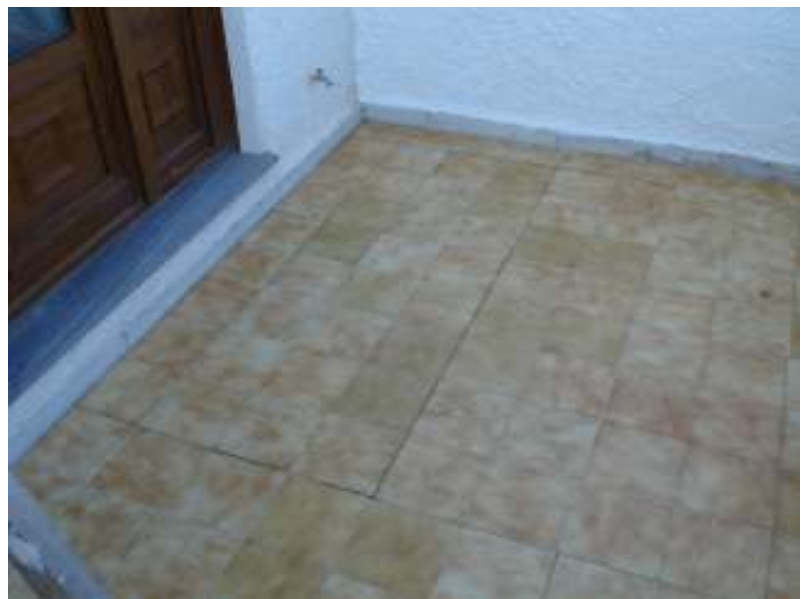
The tiling to the front terrace requires re-grouting. 1 cracked tile also needs replacing.

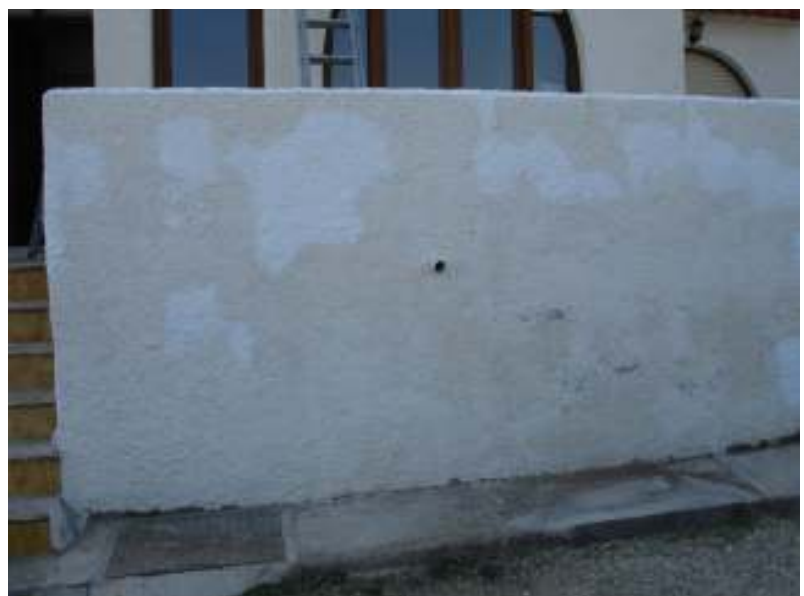
The rendered wall around the terrace is stained and requires redecoration.

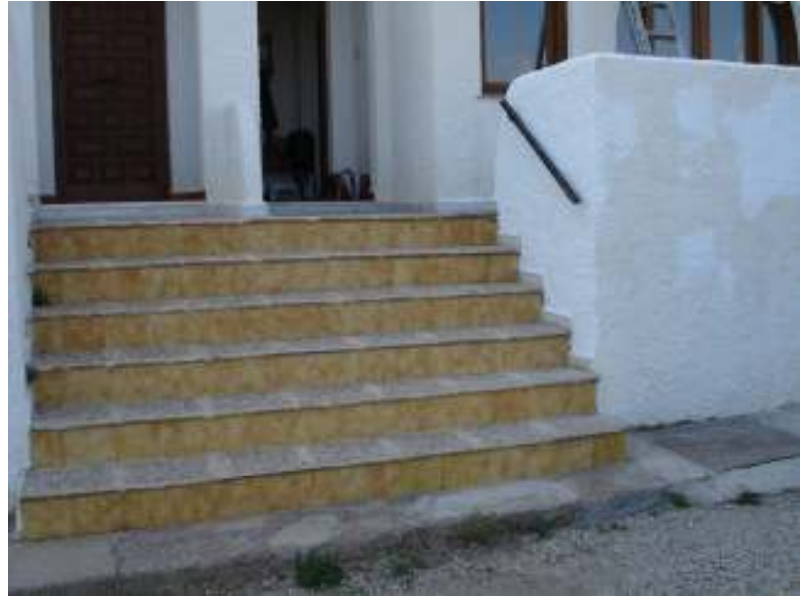
The tiles to the front steps require some re-grouting and filling.
