STRUCTURAL SURVEY

CORTIJO ANTONIO
MARTOS

DATE OF INSPECTION

4TH FEBRUARY 2007

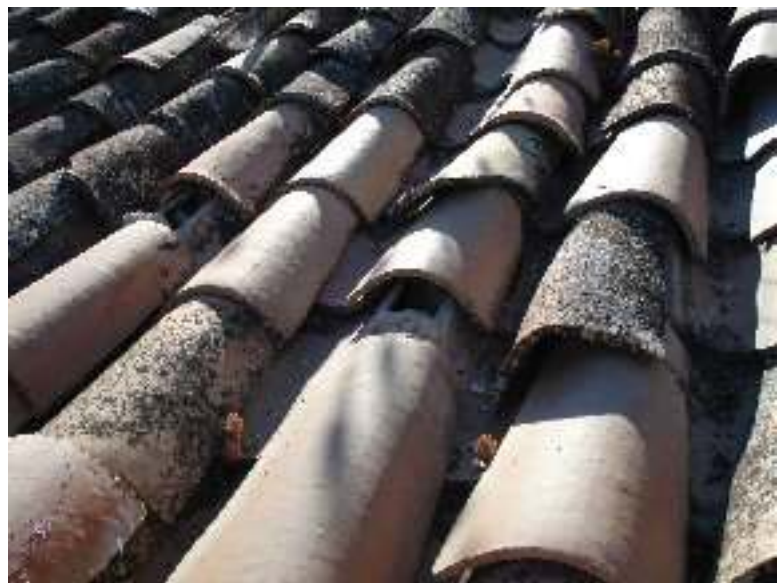
The tiles themselves are in a reasonable condition although some of these have suffered some weathering and there are approximately 12 cracked tiles.

The problem with the roof is as stated above in that the bedding beneath the tiles is breaking down and is becoming soft and loose causing slippage and unevenness of the tiles.

The roof is approaching the stage when it requires complete recovering. There is some indication of slight leakage occurring to the roof at the present time in particular around the chimney stack.

Bearing all of the above in mind it would seem prudent to immediately recover the main roof.

The roof tiles should be carefully removed and stacked for reuse. The tile bedding should then be carefully removed with care being taken not to damage or loosen the roof bricks beneath by the use of timber scaffold boards.

The roof tiles can then be rebbed on a sand and cement bedding.

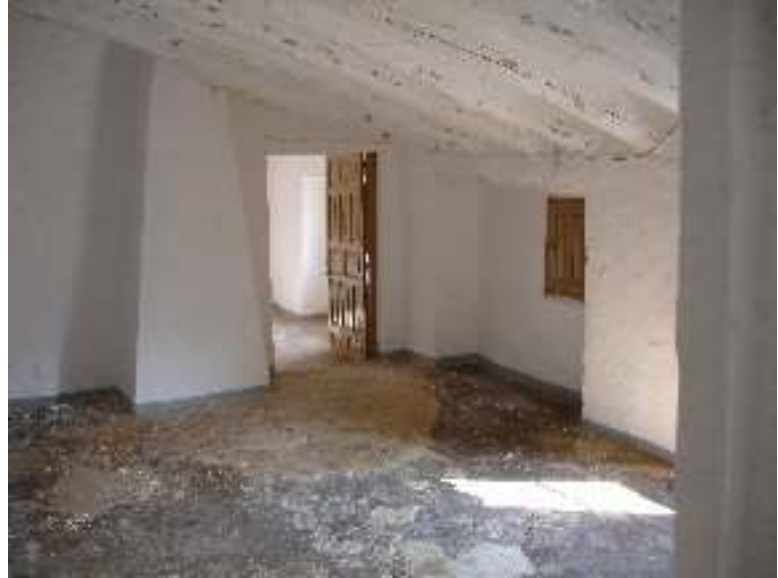
Internally, the timber beams to the roof appear to be a reasonable condition although the roof beam abutting the chimney breast has suffered some wet rot timber decay. This beam does appear to be repairable.

Several beams have suffered some splitting and there is evidence of previous attacks by wood boring insects. The splitting does not appear to be of a serious nature and the wood boring insects attack is not extensive and does not appear to be active at the present time.

Certainly, with the exception of the beam abutting the chimney breast the timber roof beams are structurally sound. There is some slight deflection/warping of several of the beams but again this is not of a serious nature.

The beam abutting the chimney breast requires local repair and strengthening utilizing short steel bars bolted to either side across the affected area. These could be recessed into the timber beam and covered with thin timber pieces to match the beam itself.

The paint to the beams should be removed and the beams treated with a timber preservative and wood boring insect treatment. The beams can then be stained, varnished or painted. The cracks and insect holes can be filled.

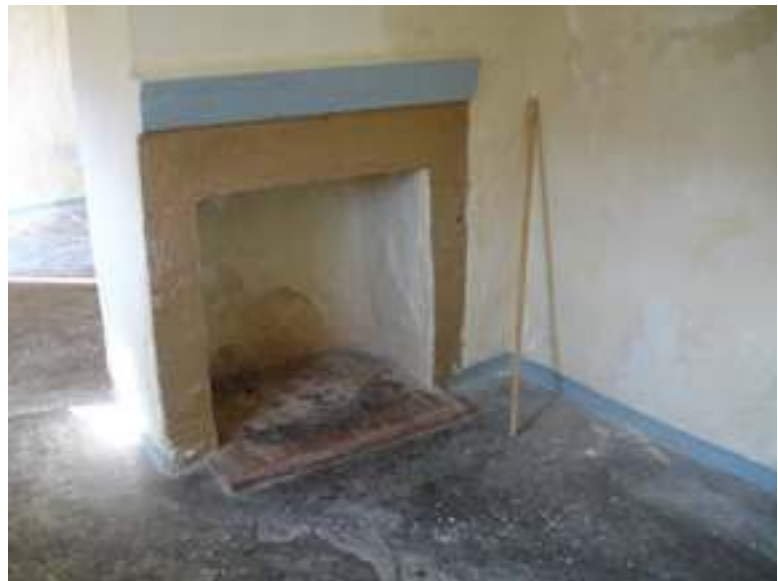
The chimney stack is in a good condition.

There has been some leakage between this and the roof covering as previously reported at this requires immediate attention.

Despite the above, the chimney breast is badly positioned at first floor. The present layout at first floor is that access to the right-hand room is directly through the central room.

However, it should be possible to replace the first-floor chimney breast and stacked with a steel flue pipe which could be positioned to serve the fireplace below and allow provision of the corridor.

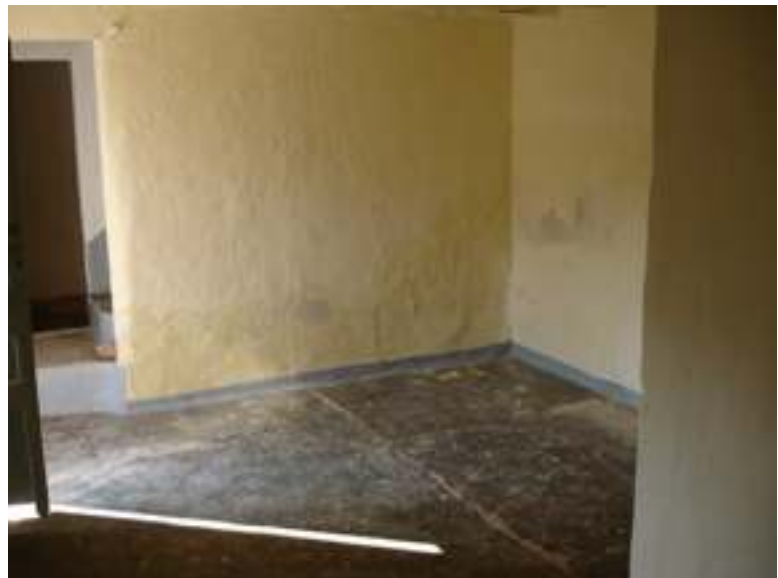
Internally, the wall surfaces are even but this can be viewed as part of the character of this type of property. Several areas of the wall surface appear to be slightly damp with discoloured, loose and flaking paint.

The internal wall surfaces will require some repair and re-rendering prior to redecoration and this is covered further under the heading Dampness & Condensation.

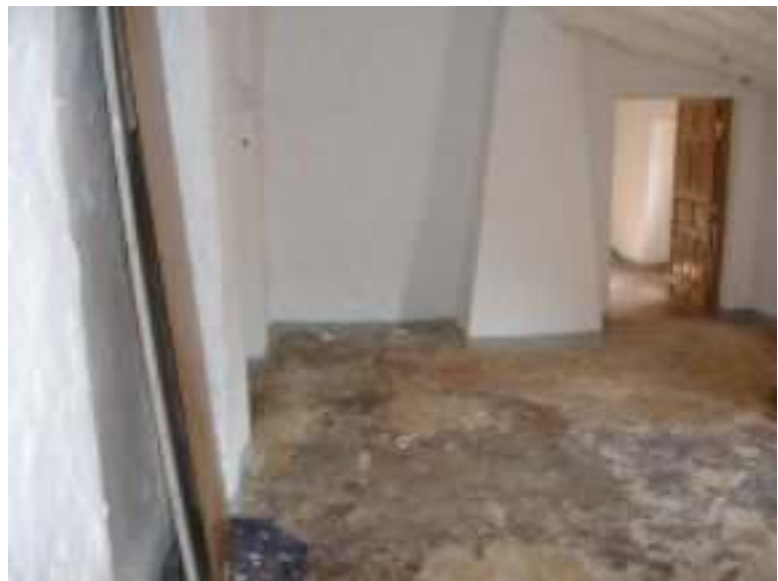
The floors at first-floor level are in a poor condition.

The floor beams are in a reasonable condition. There is no evidence of wood boring beetle attack. There is some slight shrinkage splitting to some of the timbers but this is not of a serious nature and the beams do appear to be structurally sound.

The sand and cement topping to the first floor floor areas is in a poor condition and uneven and loose to several areas but in particular to the central room.

Again the paint to the beams should be removed and the beams treated with timber preservative and wood boring insect treatment prior to redecoration. The splits can again be filled.

This is a common problem in properties all this age and type of construction. The floors should be over screeded with a sand and cement screed of approximate thickness of 30 to 40 mm incorporating galvanized wire reinforcement.

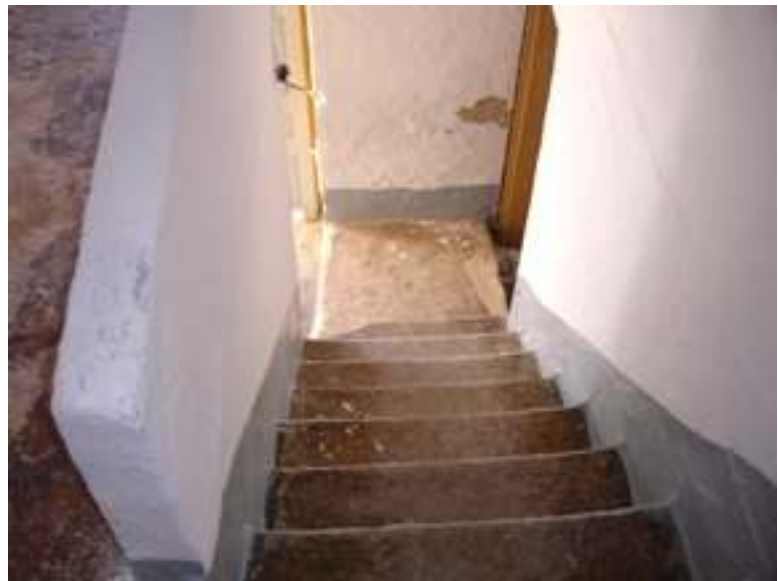
The staircase is in a good condition.

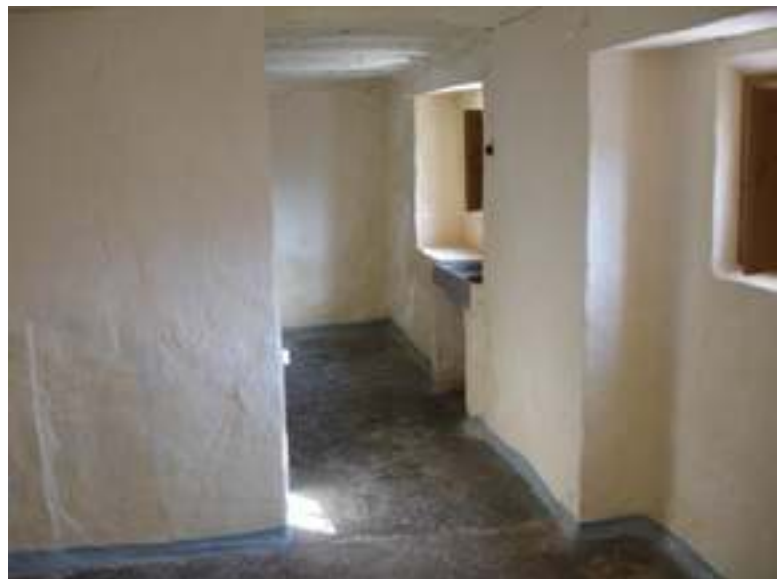
The windows are in a reasonable condition although of a somewhat basic.

The timber frames are in a reasonable condition however several of the timber shutters have suffered weathering and decay.

The windows could be prepared and improved. New timber shutters could be provided to the existing frames incorporating a glazed outer shutter and solid internal shutter hinged to the outer shutter. A fly proof screen could also be incorporated within the existing frame.

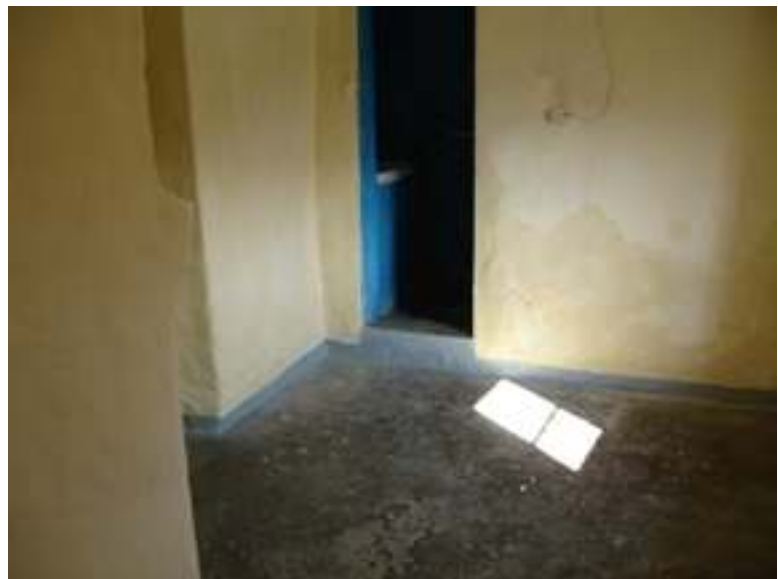
This is due to the lack of a damp proof course, the fact that the ground level to the rear of the property is slightly higher than the internal floor level and also the absence of gutters to the front.

The multiple layers of paint to the internal wall surfaces exacerbate the problem.

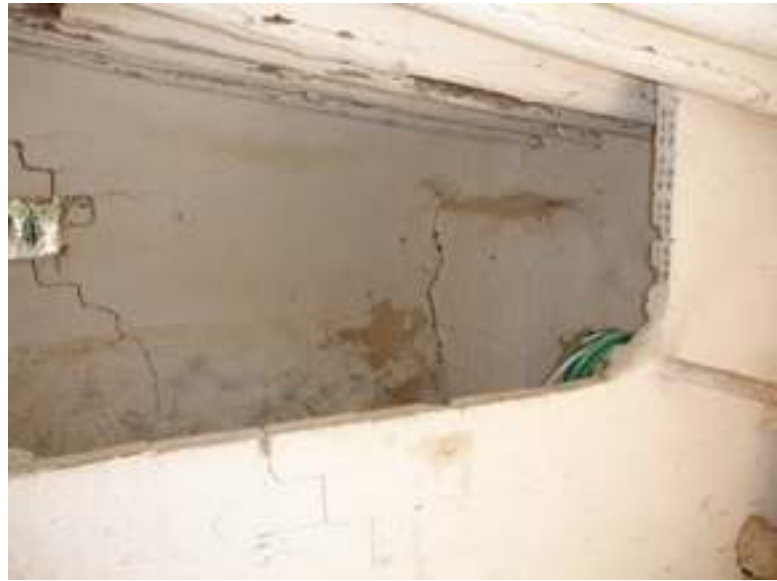
The main walls are in a reasonable condition. These have suffered some outwards movement to the front wall with quite large cracks evident between the front wall and side walls.

This movement has been due to a combination of slight foundation movement and lateral movement from the roof pushing the wall outwards.

The cracks should be repaired and as mentioned above the height of the walls will require extending slightly.

The head heights to both the internal and external door openings to this area also require raising and the provision of new concrete lintels.

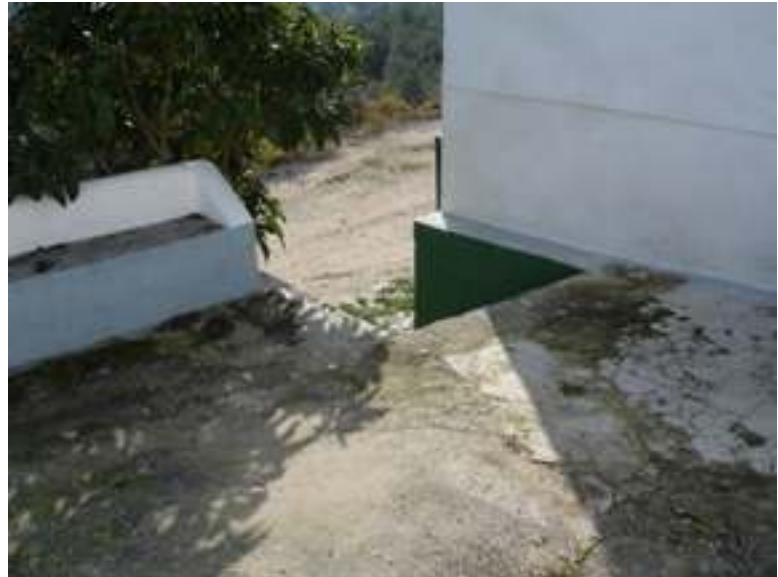
The terrace area is in a good condition although uneven. This possibly requires tiling or paving.

The front retaining wall and steps are in a good condition.
