STRUCTURAL SURVEY

A PROPERTY IN
SAN JOSE
NIJAR, ALMERIA

7TH NOVEMBER 2007

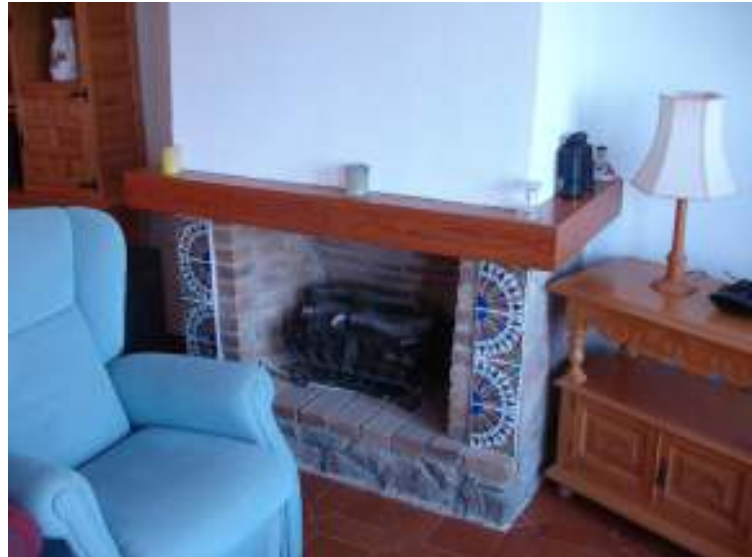
The upper sides of this are in brick and render construction although the front is formed in some sort of boarding.

The fireplace houses an electric fire.

The fireplace as such is in a reasonable condition.

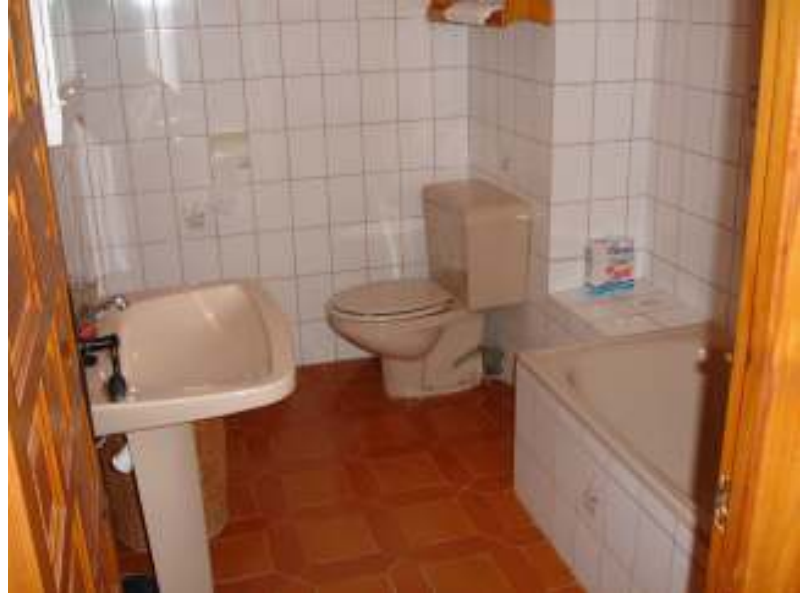
To the bathroom there is a steel bath with mixer tap and shower and curtain. There is a vitreous china wc, bidet and basin.
