STRUCTURAL SURVEY

CORTIJO ANTONIO
MARTOS

DATE OF INSPECTION

4TH FEBRUARY 2007

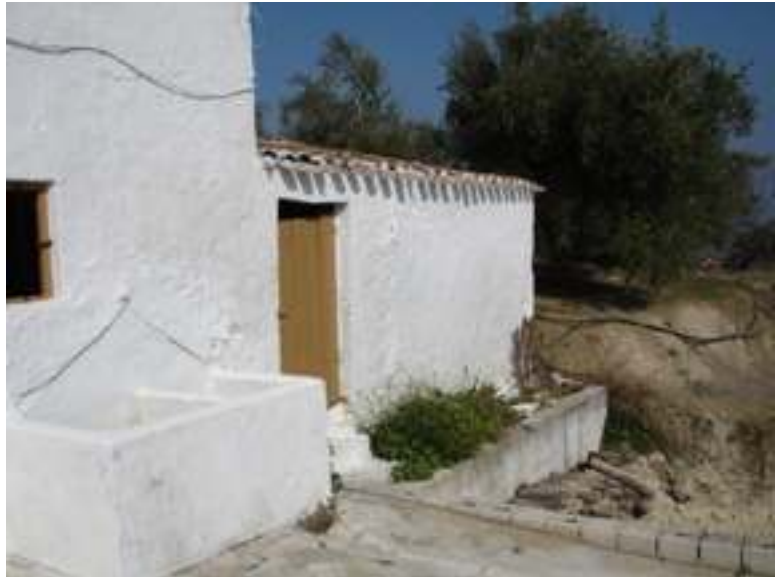
The single storey outbuilding to the right hand side of the property is of stone construction approximately 250mm thick with a single pitch tiled roof supported on timber roof beams.

There is an earth and partial concrete floor.

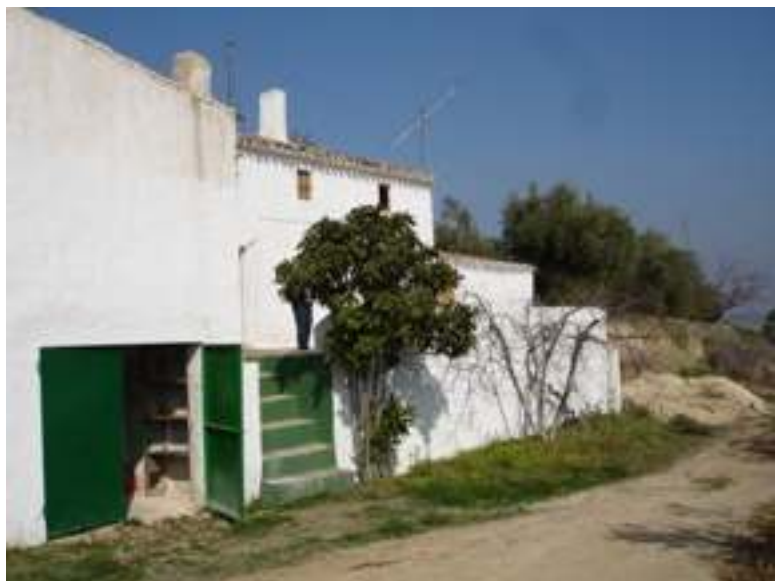
The 2 storey outbuilding to the left hand side of the property is of stone construction approximately 250mm thick at ground floor and newer clay brick construction at first floor. The first floor area does appear to have been added at a later date.

The roof consists of timber roof beams supporting corrugated asbestos cement sheeting.

The floors are of concrete on earth construction at ground floor and newer concrete floor beams supporting concrete flooring blocks and screed topping at first floor.

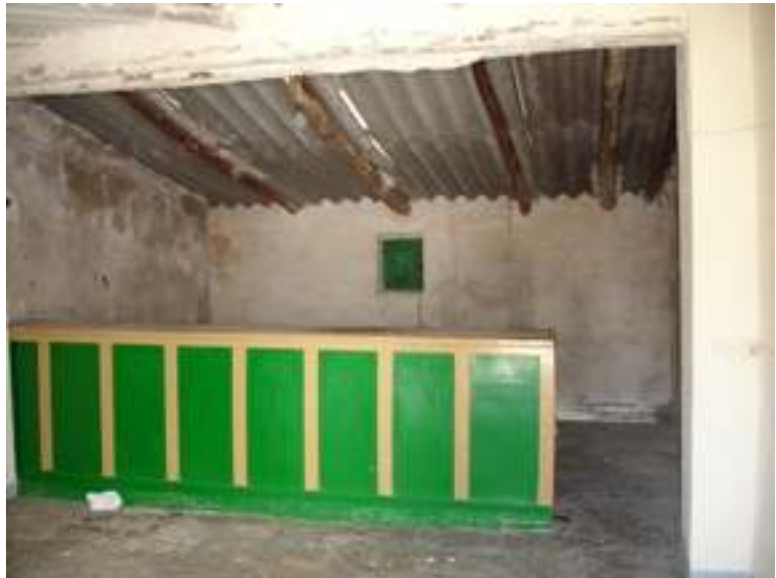
The first floor walls are in newer clay brick construction but are only 100mm thick. These could be painted internally with a waterproofing compound and then drylined with polystyrene backed plasterboard.

The roof to the outbuilding requires renewal with new concrete roof beams, roof bricks, insulation and new tiling. The roof level could again be raised slightly.

New rainwater goods would be required.

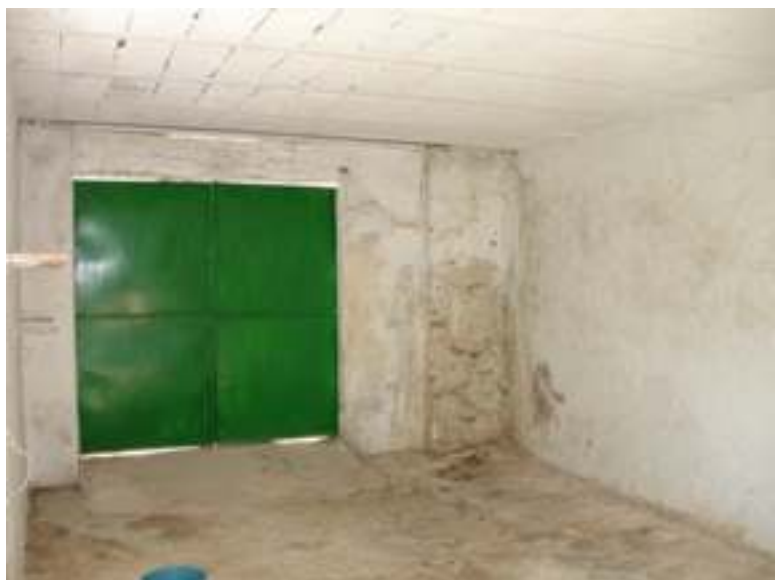
The walls at ground floor are in a reasonable condition although dampness is a problem, not least because the rear and right hand side walls are below the rear ground and front terrace levels. All ground floor walls will therefore need re-rendering internally with a damp proof render.

The external rendering to the main walls is in a good condition.

New window and door openings will be required and the double door openings infilled or altered.

New partitions will be required to provide the new room areas.

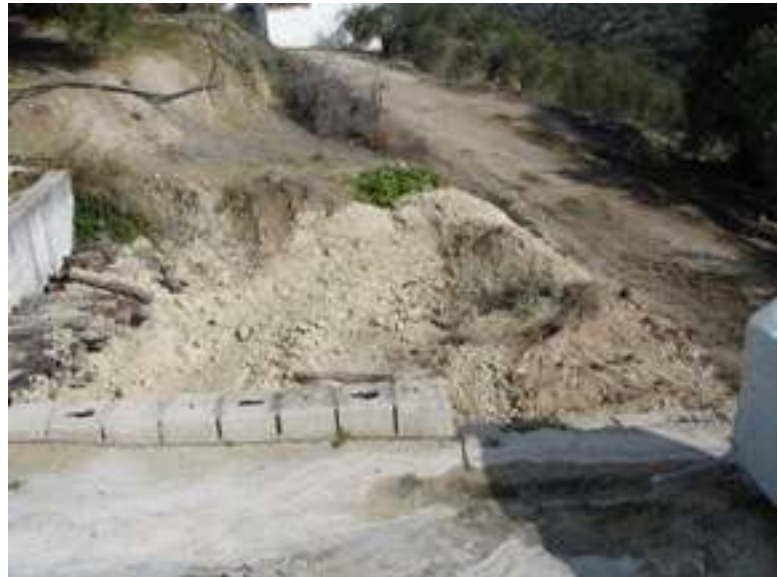
To the right hand side of the terrace there are 2 newer concrete block retaining walls around a lower rectangular piece of land, the rear wall runs along the front of the right hand outbuilding as previously reported.
